## Zipp to Recall First Generation 88 Front Hub

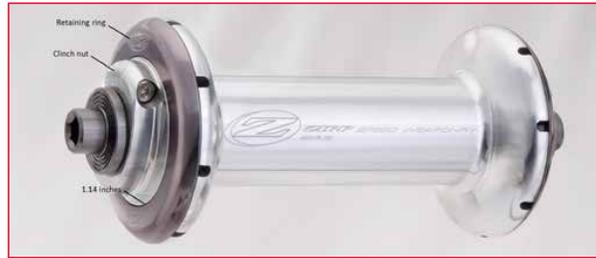
Image 1 – First generation Zipp 88 hub

Zipp has identified a technical issue with respect to a production range of Zipp wheels manufactured with the Zipp 88 front hub. We have begun the process with the CPSC for a complete recall. The root of this recall is spoke retention, a concern only with first generation front hubs. Specifically, the first generation 88 hubs could incur retaining ring failure that might result in an ejection of all the wheel's spokes. This may result in wheel failure.

**4.** To further identify the first generation Zipp 88 hub is the presence of "Z" logos on the retaining rings. (Refer to images 1 and 2 below). No other versions have logos on the retaining rings. The hub shell is silver, and the retaining rings are gray in the standard option and gray, red, blue, pink, or gold in the ZedTech options. The outside diameter of the two clinch nuts is approximately 1.14 inches. (29mm)

Image 2 – additional view

The ABOVE images are the affected first generation Zipp 88 Front Hub. The retaining ring is colored, with a “Z” and smaller clinch nut.

We want to make this process as convenient as possible for everyone and return consumers to riding quickly. After identifying that that hubs are part of the recall consumers are encouraged to bring them into their local SRAM or Zipp dealer who will immediately initiate the warranty process. Most consumers will have their wheels rebuilt with new parts and incur no cost. If consumers are unable to reach their dealer, or have additional questions or need for assistance, they are encouraged to call SRAM’s Dealer and Customer Service directly during regular business hours at 1-800-346-2928 or 1-800-231-6755.

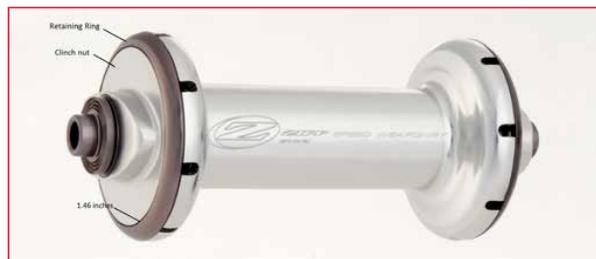
Image 3 – Unaffected Hub

The BELOW images are a Zipp front hub that is unaffected by the Recall. Note the larger, silver, clinch nut and smaller retaining ring.

Image 4 – left side Affected, right side Unaffected

5. The affected hub has a Ring and Nut like the parts on the Left (colored ring, with a “Z” and smaller clinch nut). The parts on the Right shows a non-recall unaffected ring and nut. Note the larger (37mm diameter) nut and the smaller ring without the “Z”. (IMAGE 4)
